GVW-DUAL-HORNS

Dual Horn Upgrade [80-91 Vanagon]

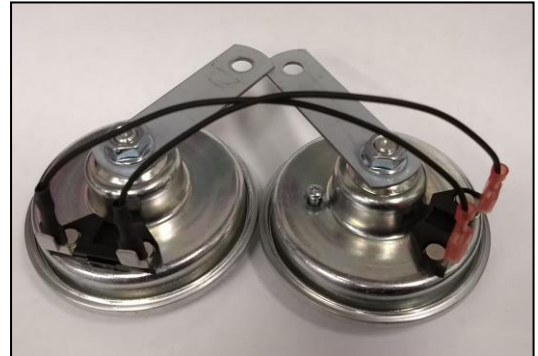
1. Remove the old horn by prying off wires and removing the 8mm bolt.
2. Bolt the new dual horns the same location, bending the mounting tabs to the desired orientation. Use the provided jumpers to wire the horns in parallel, as pictured. Attach the black/yellow and brown/blue horn wires to the piggyback connectors on the jumpers. This may require trimming back some of the insulating rubber boots around the factory horn wires.

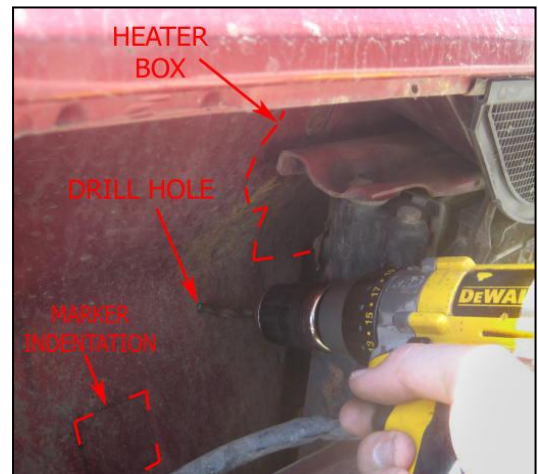
1. Remove the old horn by prying off wires and undoing the 8mm bolt.
2. Remove the glove box, taking note of the square indentations in the cowl. Then remove the upper grill and the passenger headlight assembly. Drill a 5/16" hole through the front cowl (just below the roll in the sheet metal). Use the small square indentation in the sheet metal as a reference marker (see photo).

3. Using the included hardware, bolt the horns into place. This may require help from a friend inside the vehicle. A bit of silicone sealant will weatherproof the connection. The tabs on the horns can be bent with pliers to fit as desired.

4. Use the provided jumpers to wire the horns in parallel, as shown in the picture above. Attach the black/yellow and brown/blue horn wires to the piggyback connectors on the jumpers. This may require trimming back some of the insulating rubber boots around the factory horn wires.
